AVIATION INVESTIGATION REPORT

A00O0210

DIFFICULTY TO CONTROL

CESSNA 150G C-FVDR

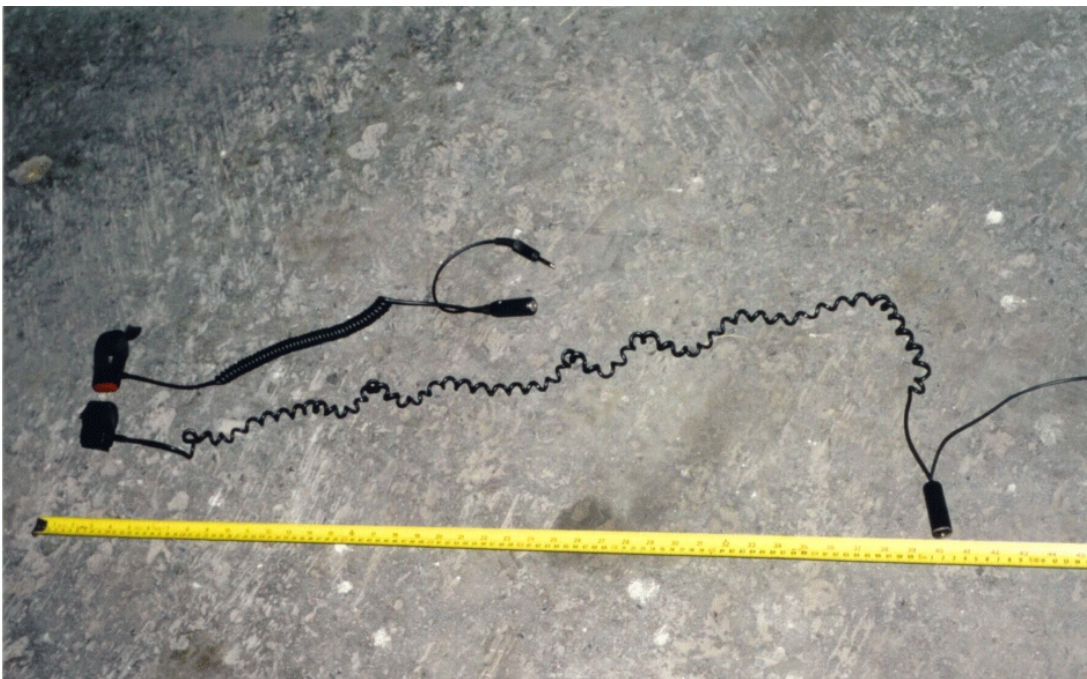
Figure 1 - Top: left push-to-talk cord (new). Bottom: right push-to-talk cord (old).

An examination of the flight control system did not reveal any anomalies that could have restricted or jammed the elevator controls. During the examination of the aircraft, it was noted that the cabin air control knob (ancillary control), which is located on the right side of the instrument panel, was pulled fully out. The aircraft had been modified to facilitate the use of headsets and boom microphones. This included the installation of a radio panel in the centre of the dash, with receptacles for the push-to-talk connections. A push-to-talk button was attached to each control column by a velcro strap. A spring-coiled electrical cord led from the push-to-talk button to the receptacle on the radio panel. The spring-coiled cord on the left side was new and approximately two feet long when contracted. The cord on the right side, which was old and had lost most of its recoil, was approximately four feet long when relaxed. It was common practice for the instructor in the right seat to take up the slack in the electrical cord by wrapping it around the right control column eight or ten times.

1. The push-to-talk cord on the right side of the aircraft was stretched to twice its normal length and wrapped loosely around the control column. The cord could therefore become entangled on the aircraft ancillary controls.
2. It is likely that the push-to-talk cord became snagged on the cabin air control knob, restricting the movement of the elevator control.

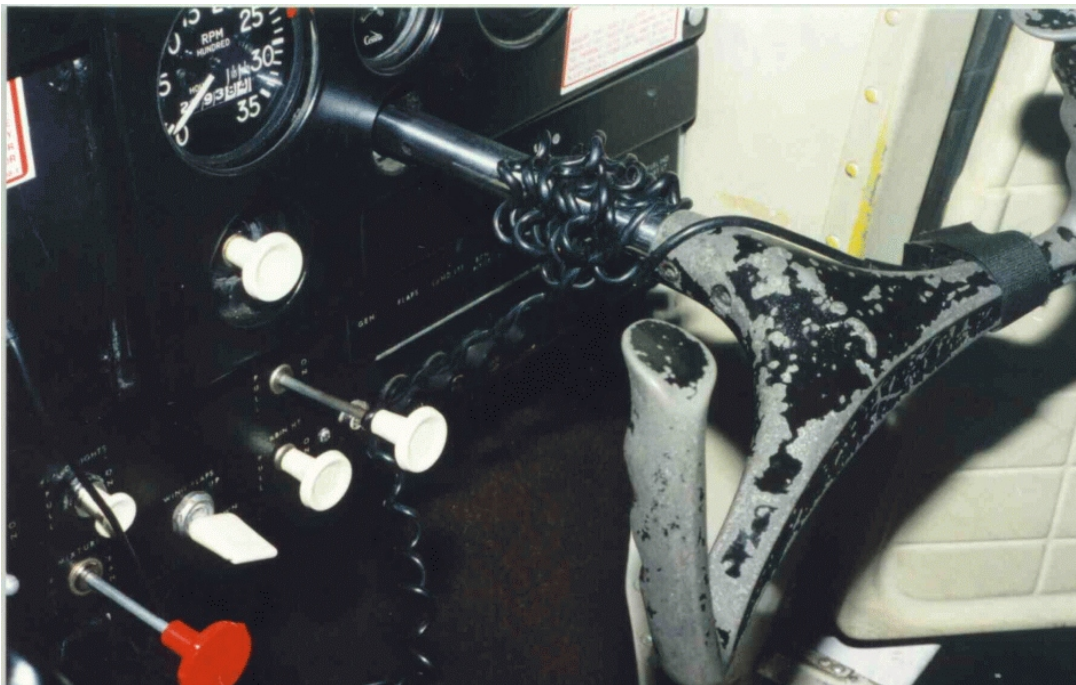
Figure 2 - The right control column movement probably was restricted by the push-to-talk cord, which snagged on the cabin air control knob.

When the aircraft landed, the elevator control system was functioning normally. There was no binding or indication of any previous binding in the elevator system, nor was there an indication of any damage to any part of the elevator system. The cause of the restriction in the elevator control system had to be something subtle and transitory. The investigation revealed that if the push-to-talk cord was wrapped loosely around the control column, a single loop could snag on the cabin air control knob, and the electrical cord would then restrict the aft movement of the control column. This likely happened as the student was attempting to recover from the stall. The action of pushing the control column forward likely allowed a loosely wrapped electrical cord hanging from the right control column to swing forward and snag the cabin air control knob. The fact that the aircraft was in a nose-down attitude would also tend to allow the loop to swing forward. When the control column was pulled back, the cord would remain snagged and tighten on the knob. This was most likely the condition the aircraft was in

when the instructor took control from the student. During the landing approach, when the control column was moved forward to compensate for the flap selection, the tension on the cord would have relaxed, allowing the cord to swing free of the air control knob, freeing the control column through its full travel.
